NASA CR-2166

FAILURE ANALYSIS OF  
ALUMINUM ALLOY COMPONENTS

*by Om Johari, Irene Corvin, and Joseph Staschke*

*Prepared by*  
IIT RESEARCH INSTITUTE  
Chicago, Ill. 60616  
*for Langley Research Center*

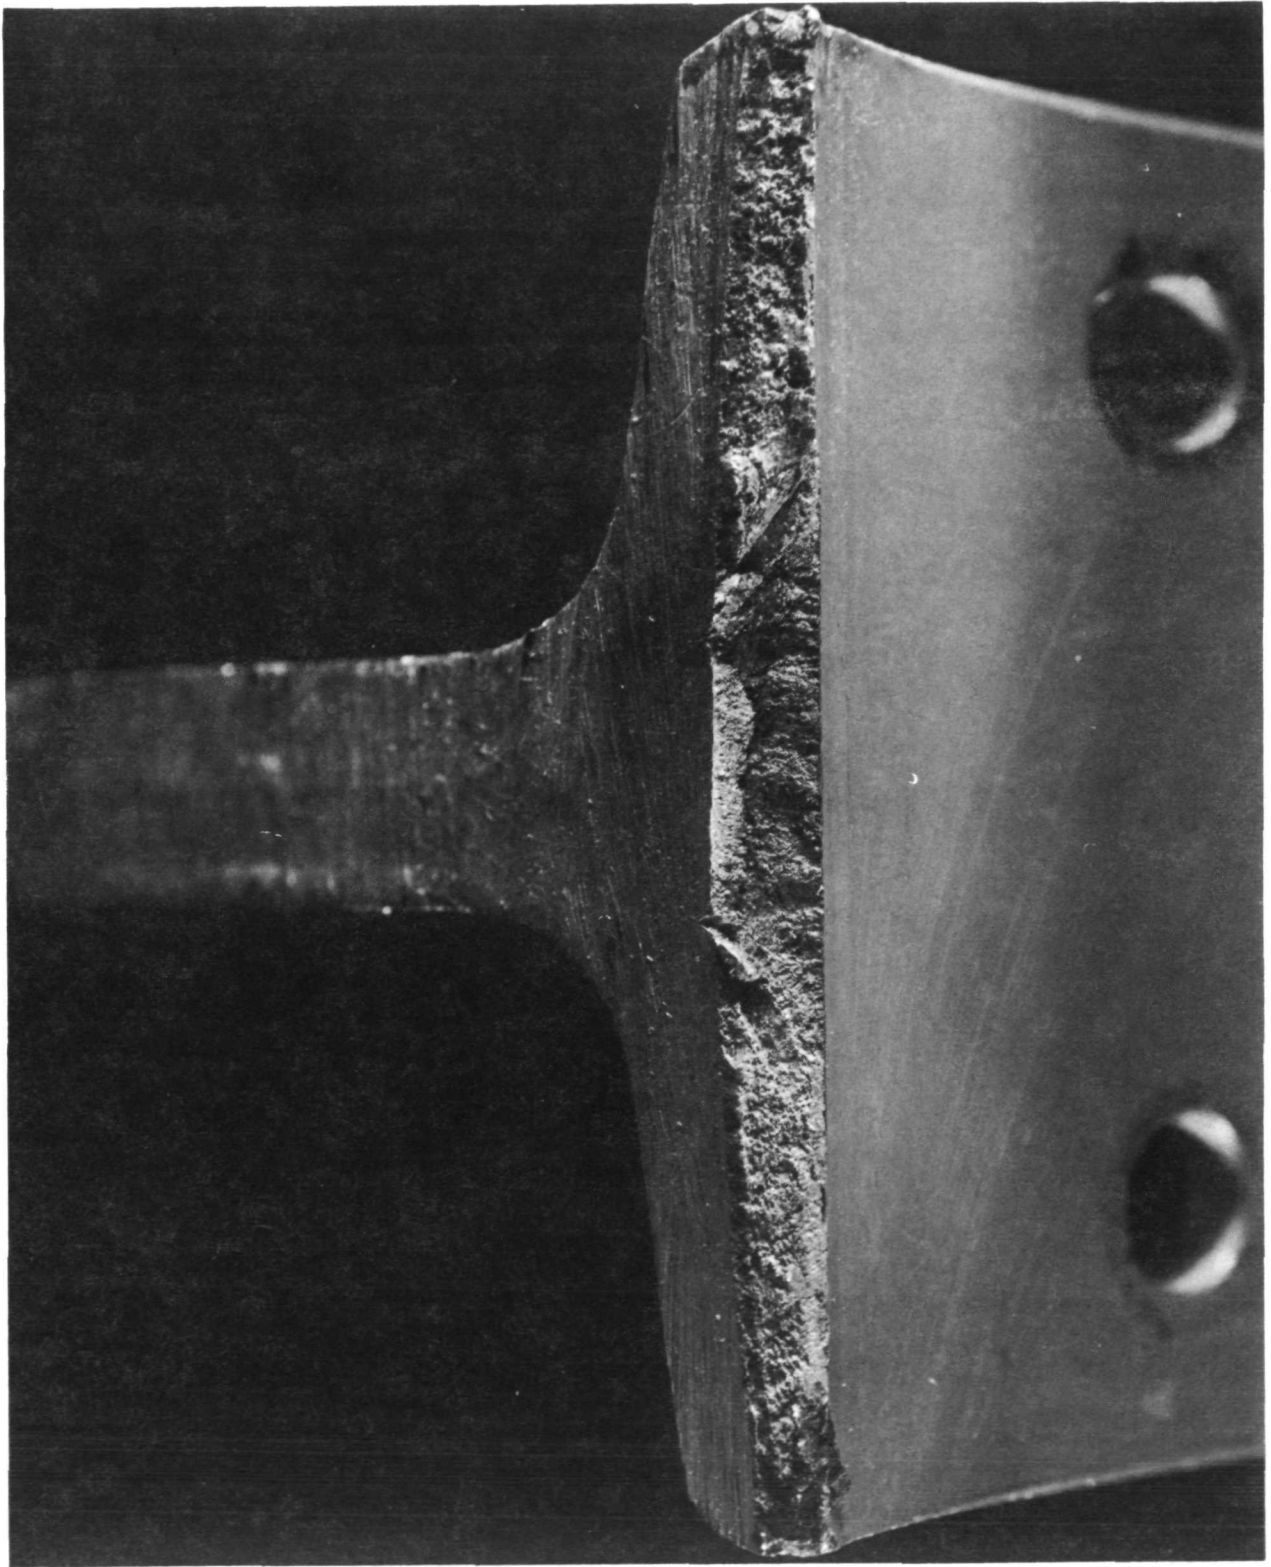
Figure 1  
Overview of Failed Aluminum Flap Hinge Fitting in the  
As-Received Condition.

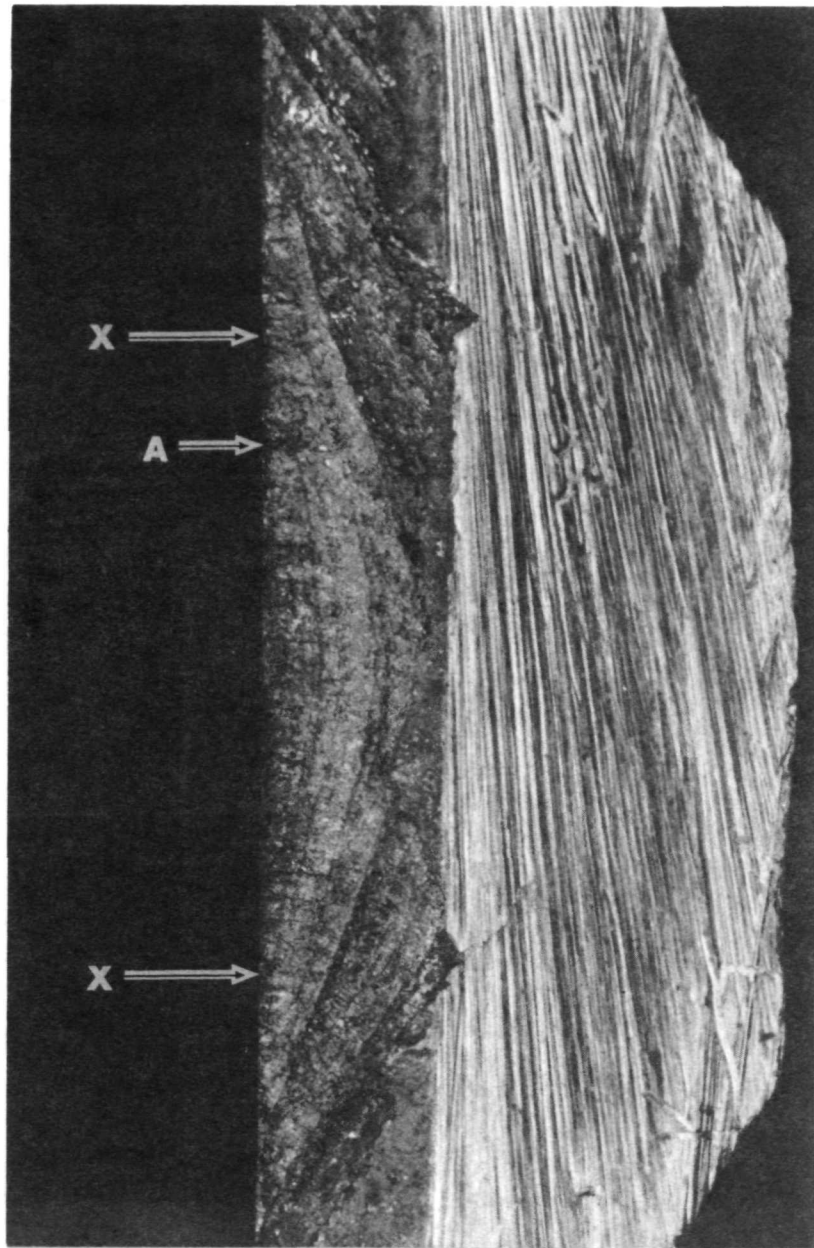
Fig. 2

The crack started by fatigue although no specific origin could be found. Figures 3 to 6 suggest that there were probably many local sites and the cracks grew from each to form the appearance in Fig. 2. The specimen edge was subsequently polished and examined in an attempt to find specific clues as to the origin, but without success. The possibility of inclusion-initiated origin is thus ruled out, though surface defect (scratch) or local overload may have initiated the failure. These hypotheses would be verified if similar cracks are found in other flap hinges.

Photomicrograph of the Fracture Surface,  
Showing the Fatigue-Initiated Fracture  
Face Appearance.

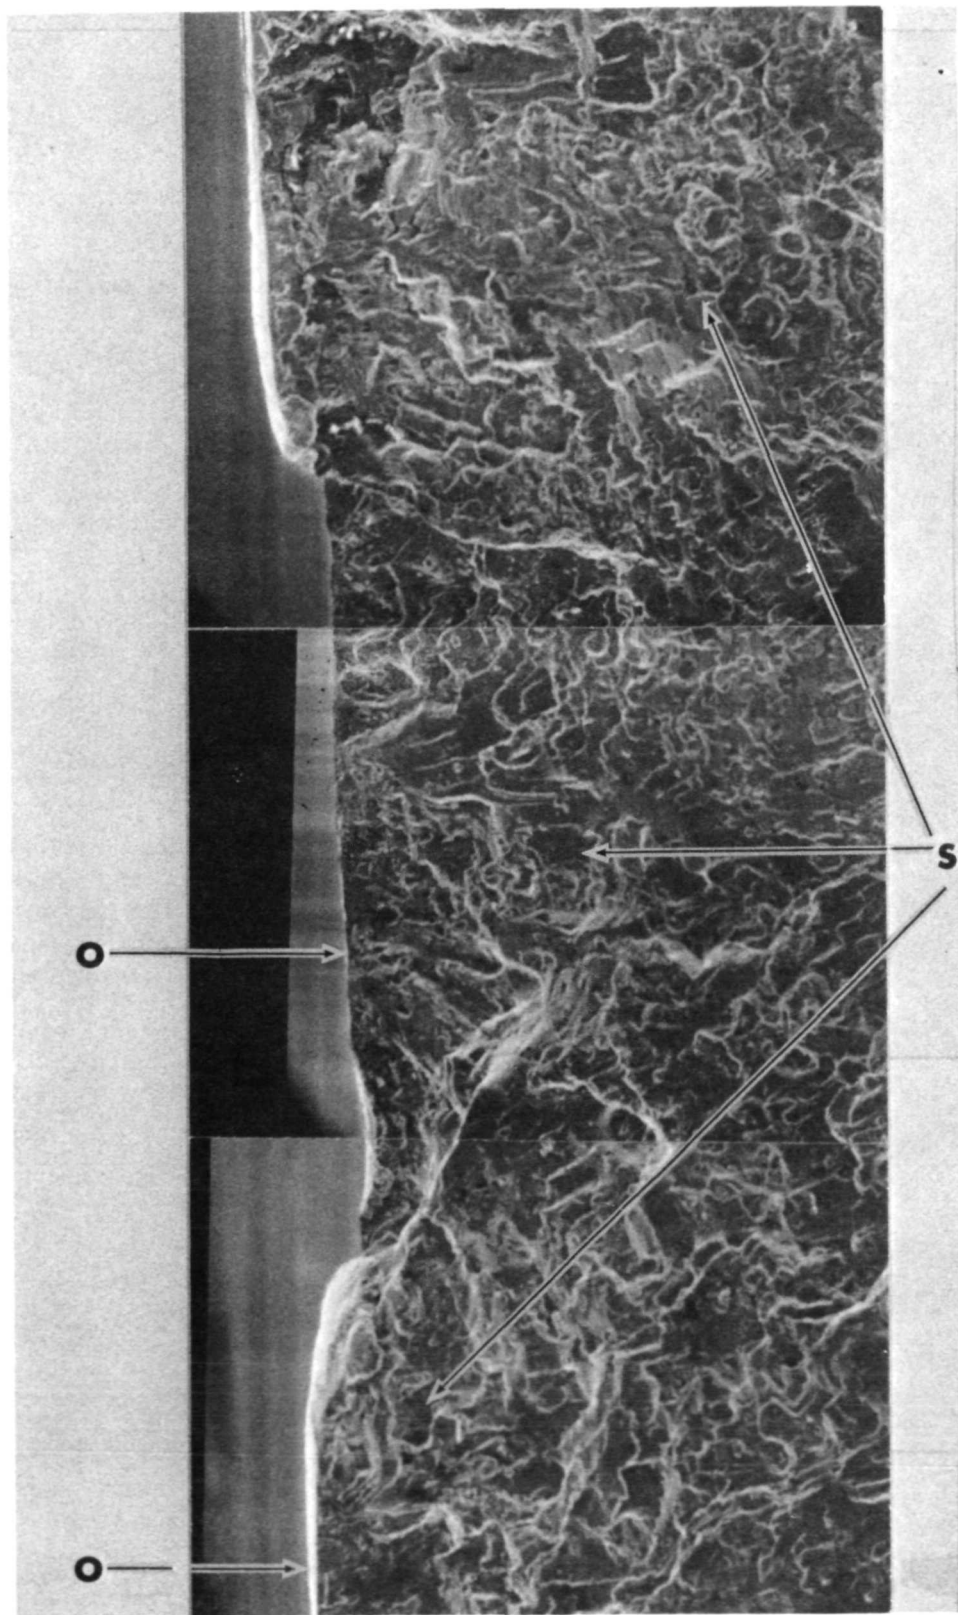
Fig. 3

Region A of Fig. 2 is magnified in Fig. 3. Even at this low magnification many fatigue features are evident. A close examination of this photograph shows many fatigue striations. SEM examination enabled the striations to be observed at this low magnification. Many other areas along the crescent-shaped edge showed similar features. Some typical areas are shown in Figs. 4 to 6. In addition, several high-magnification photographs illustrating the fatigue striations are presented in Figs. 7 to 9.

Composite Photograph of Region A in Fig. 2. Notice the presence of striations at areas S. This photo suggests that areas O could be possible origin.

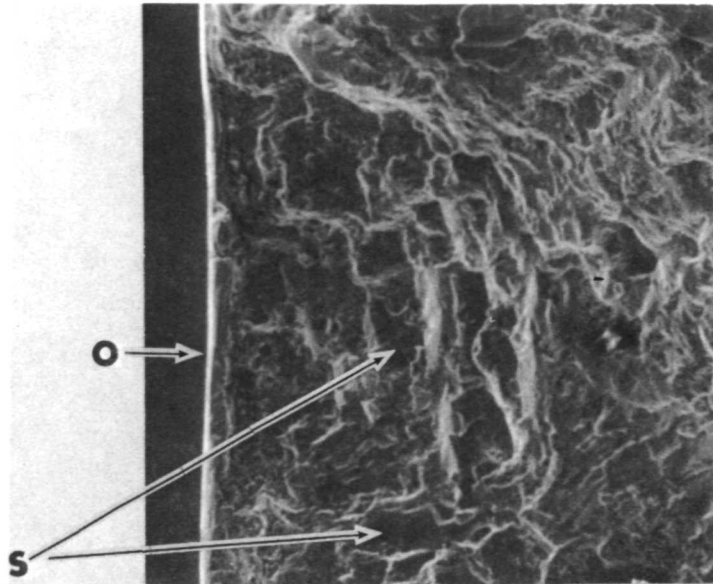
Fig. 4 Mag. 155X

Another Region Close to the Edge.  
Areas S again show striations.  
Region O could be another  
possible origin.

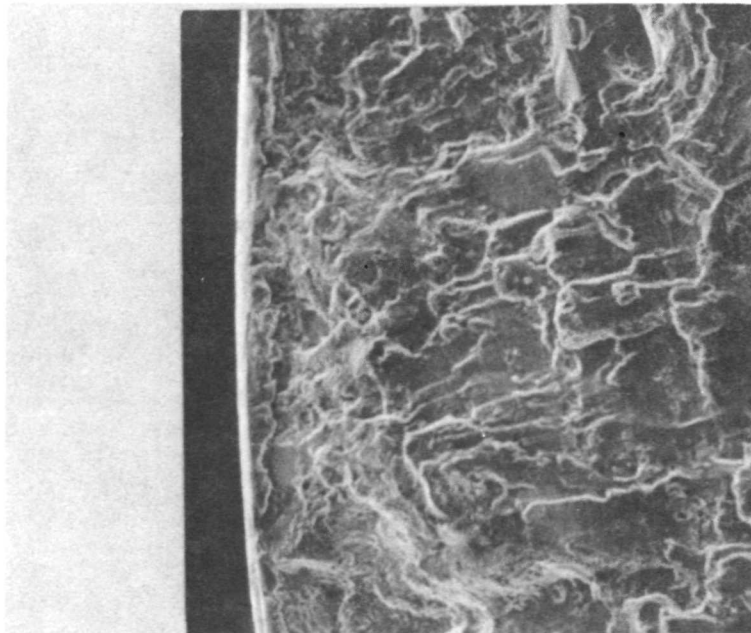
Fig. 5 Mag. 230X

Another Possible Initiation Site.  
Notice the ease with which  
striations can be discerned at  
this low magnification.

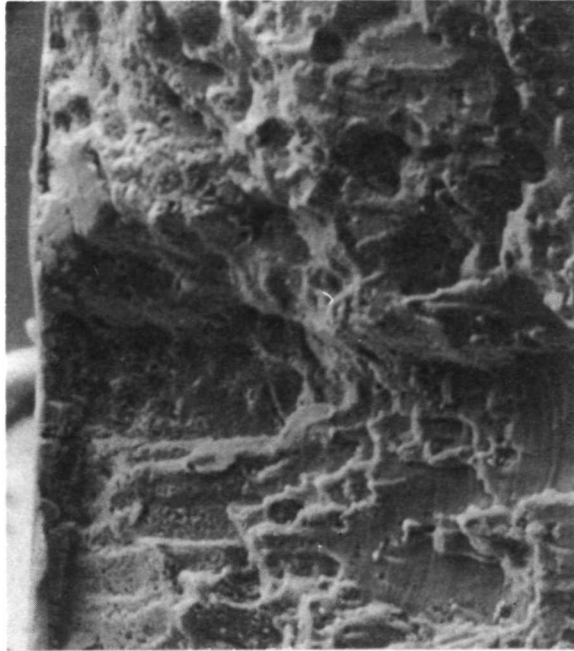
Fig. 6      Mag. 200X

Yet Another Possible Initiation  
Site. Many such regions were  
identified all along the region  
XX of Fig. 3.

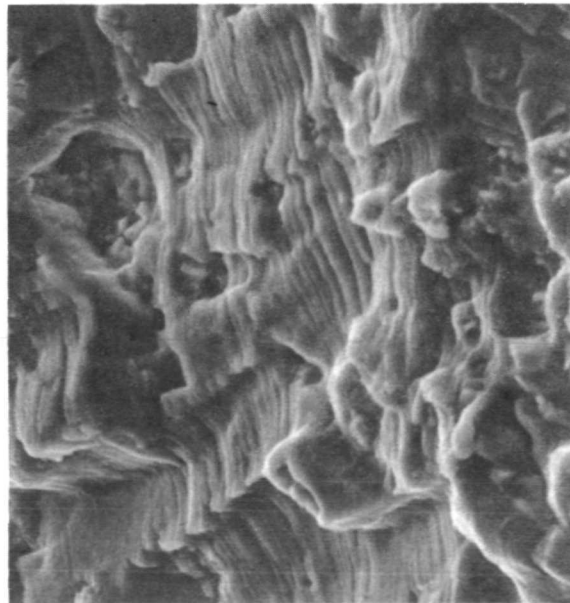
Fig. 7      Mag. 600X

Fatigue Striations at Higher  
Magnification.

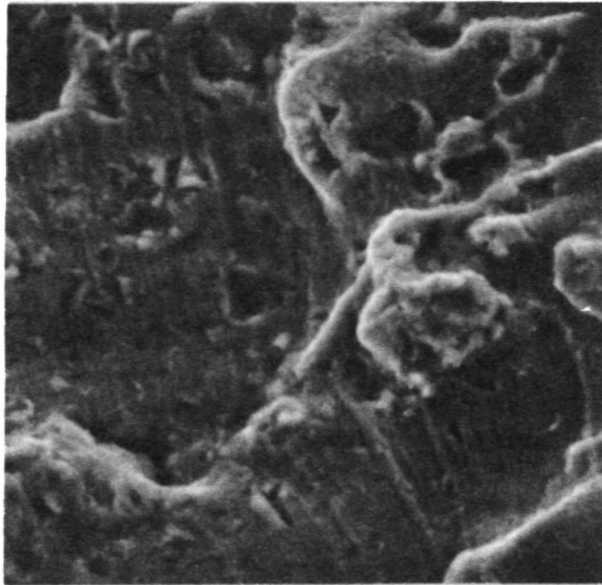
Fig. 8

Fatigue Striations in Another Region.

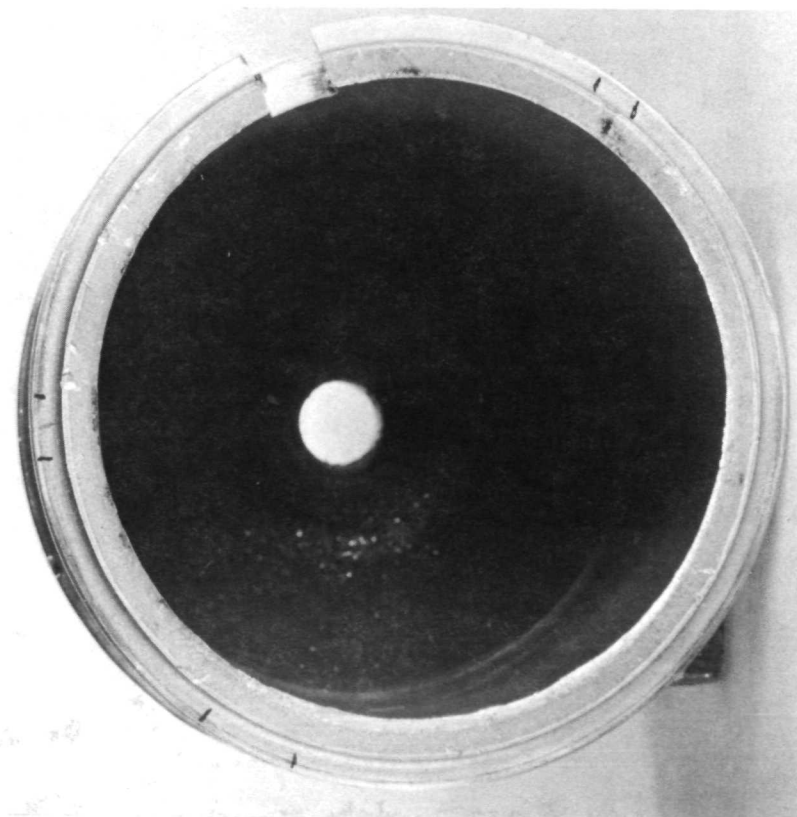
Figure 1  
Plan View of Failed Aluminum  
Shock Strut Piston  
(Courtesy Naval Air Development Center)

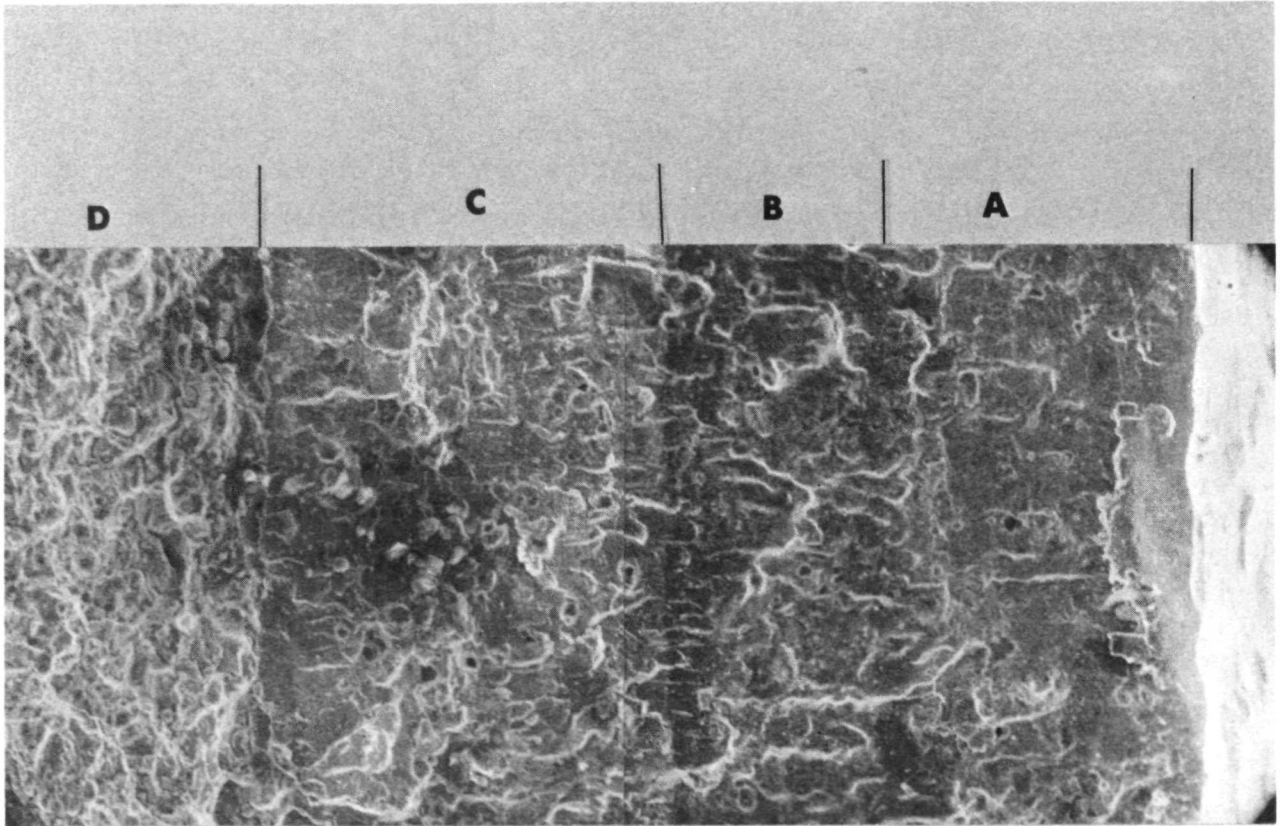
Figure 7

Region at the Center of SS in Figure 6, Showing Four Distinct  
Regions A, B, C, and D.

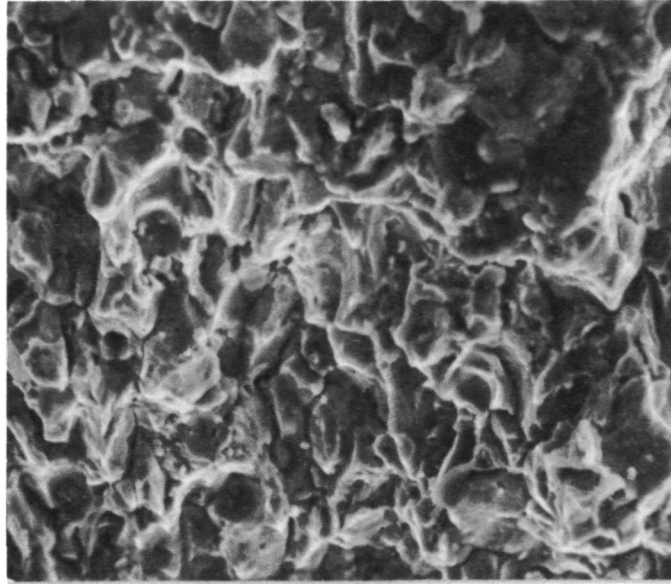
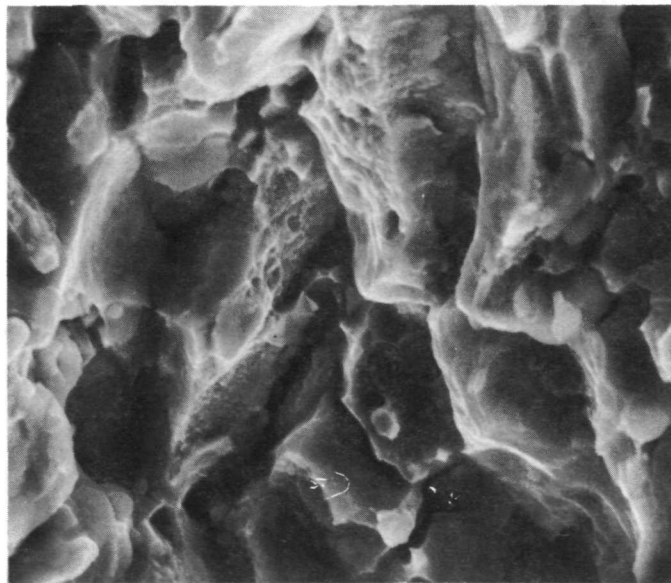
Figure 8

Typical Features of Region D in Fig. 7  
Showing Overload Failure

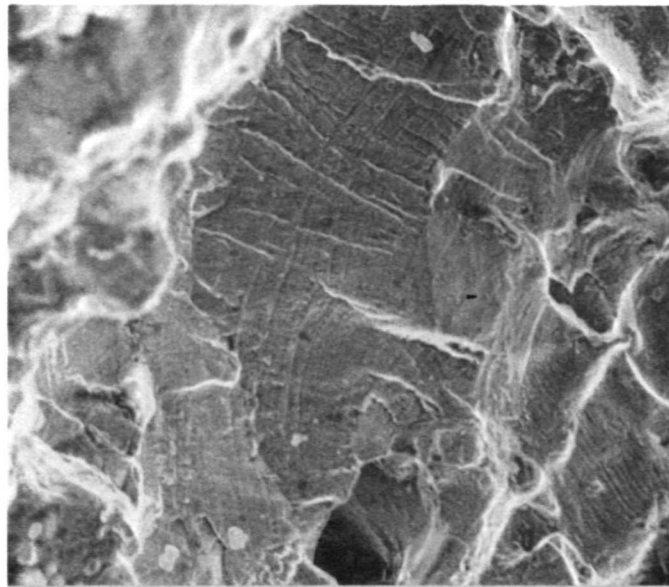
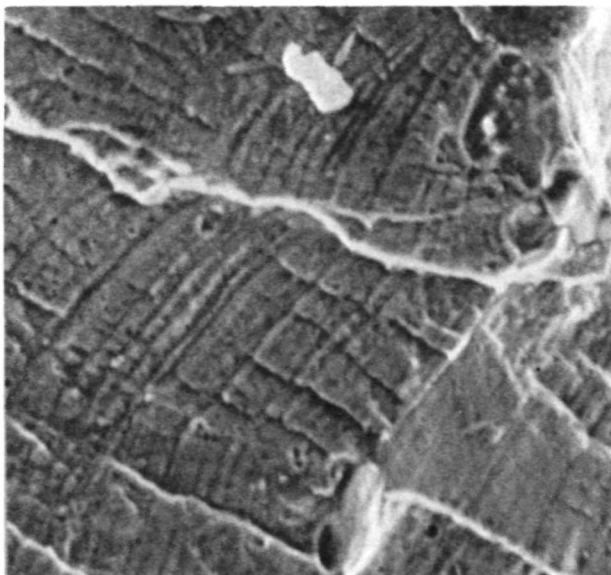
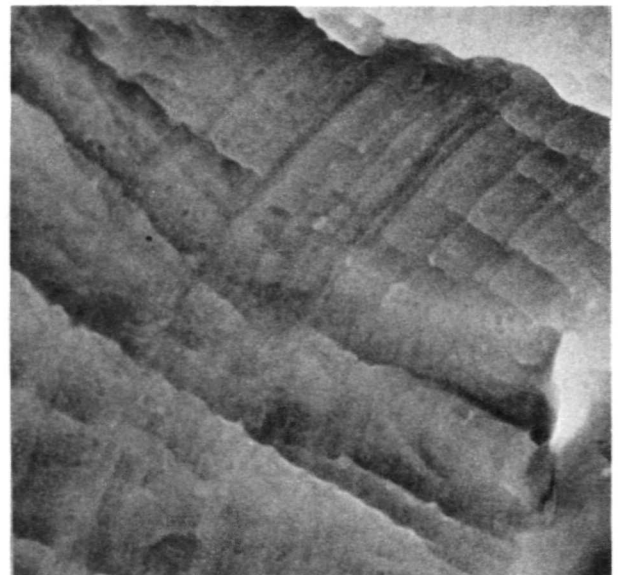
Figure 10

Fatigue Striations in Region C. (a) Low magnification; while most striations point to the center of SS as origin, local differences in striation direction, attributed to individual grain orientation, are also seen. (b) Higher magnification of the top central region in (a). (c) Another region showing striations in region C. The SEM was operated at 25 kv for this photograph and at 5 kv for the photographs in (a, b); this accounts for the different appearance.

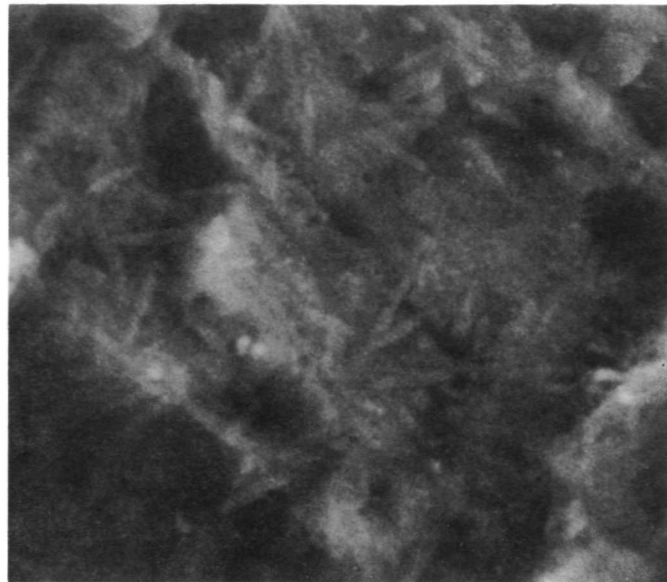
Figure 12

Details of Contaminants Covering  
Most of the Region B.

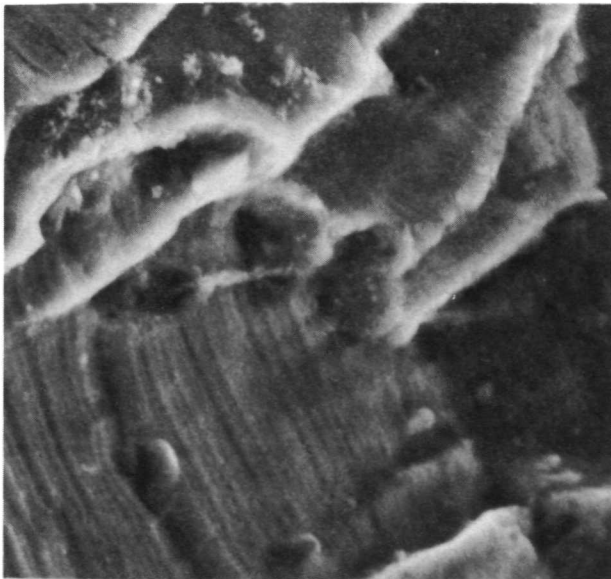
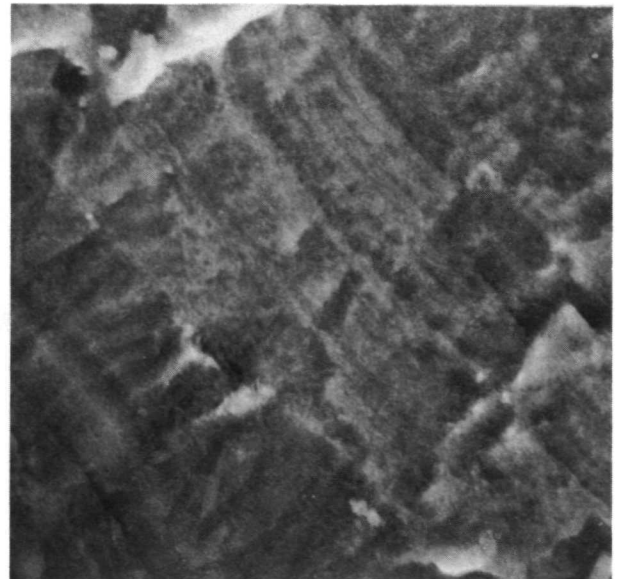
Figure 13

Fatigue Striations in (a) Region C and (b) Region B. The striations are clearer and sharper in region C than in region B, where they are obscured by contaminants.

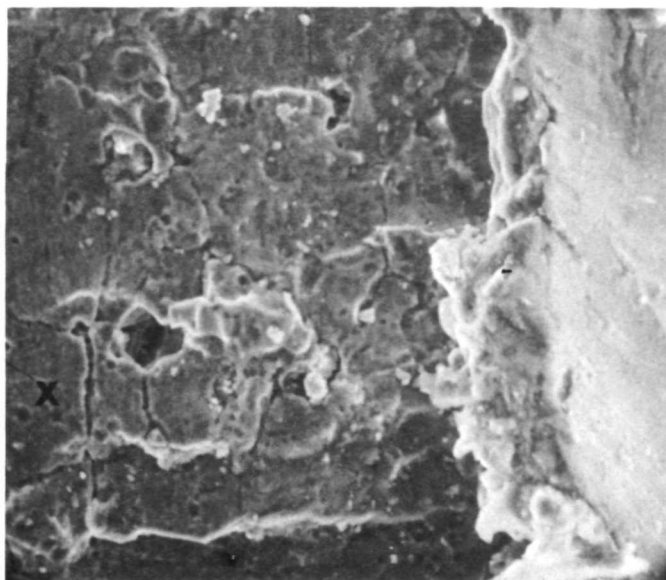
Figure 14

In region A, no specific initiation point could be found; Fig. 14 is a high-magnification photograph of this region. Grain boundaries were separated and were clearly identified in most areas of region A. The structure here appears to have been induced by chemical attack (Fig. 15).

The identical nature of A areas (Figs. 14 and 19) in SS regions (there were at least five such regions at various points on the circumference of the section received) and outside SS is attributed to (1) continuous rubbing and smearing in this area which fractured first, and (2) chemical attack resulting from exposure to corrosive environments during the life of the

part since this area, being closest to the specimen surface, suffers maximum exposure. Also, alkaline solutions are used to clean aluminum alloy components, and the structure in Figs. 14 and 19 could arise from the use of such solutions before the crack opened beyond the initial stages of region B.

High-Magnification View of Region A  
at the Center of the Fracture Edge  
in Figure 7.

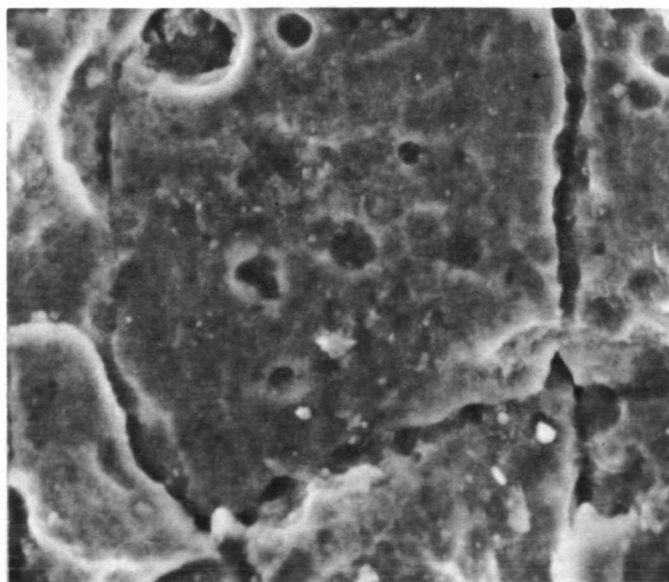
Figure 15

Details of Grain X in Figure 14, Showing  
Pitting and Grain Boundary Attack.

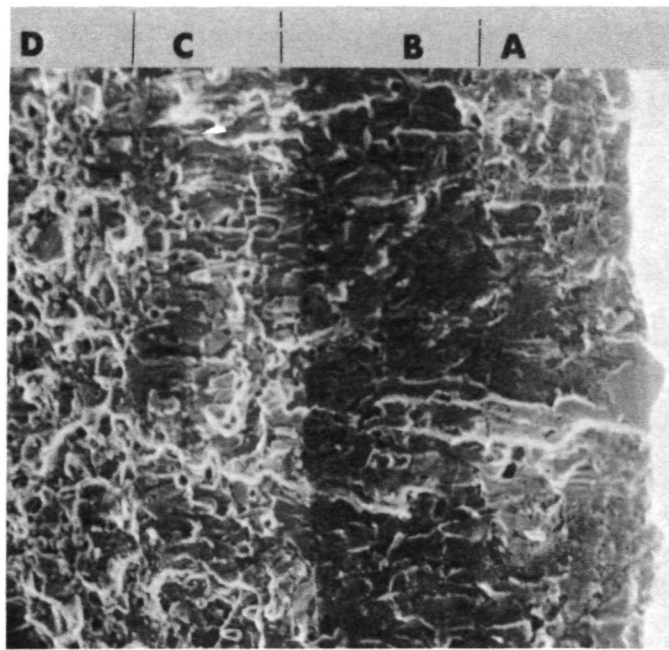
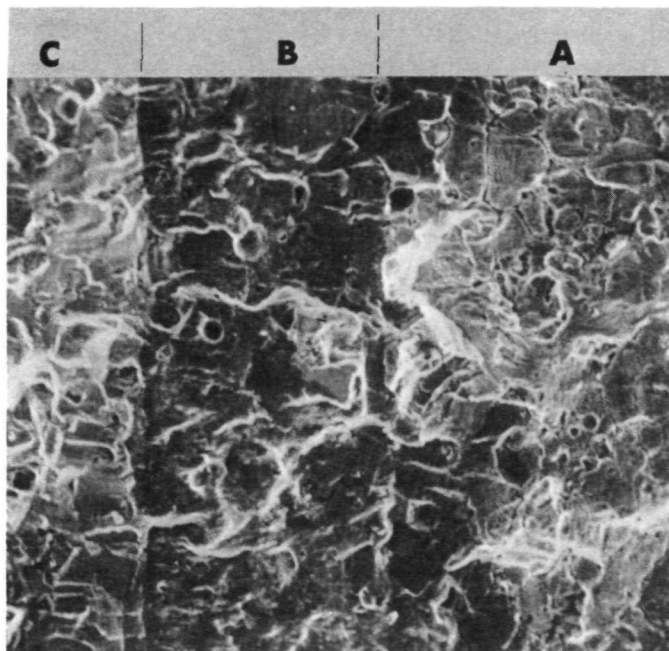
Figure 16

In the area outside the suspect-origin region described above (i.e., outside the region SS of Fig. 6) four similar regions were observed (Fig. 16 a, b). The features of regions C and D were identical. In all areas of regions B and C the striations were parallel to the circumference of the sample (Figs. 17 and 18). The darker region B (Fig. 17 a, b) was again more contaminated than region C, and though fatigue features are suspected, they could not be clearly resolved. In Fig. 18 a, b, and c the boundary between B and C is, again, very distinct. Area A (Fig. 19 a, b) is also very similar in the regions inside and outside SS of Fig. 6.

Two Areas Outside the Crescent-Shaped Suspect Origin Region SS. Four regions (A, B, C, and D), identical to Figure 7, are observed.

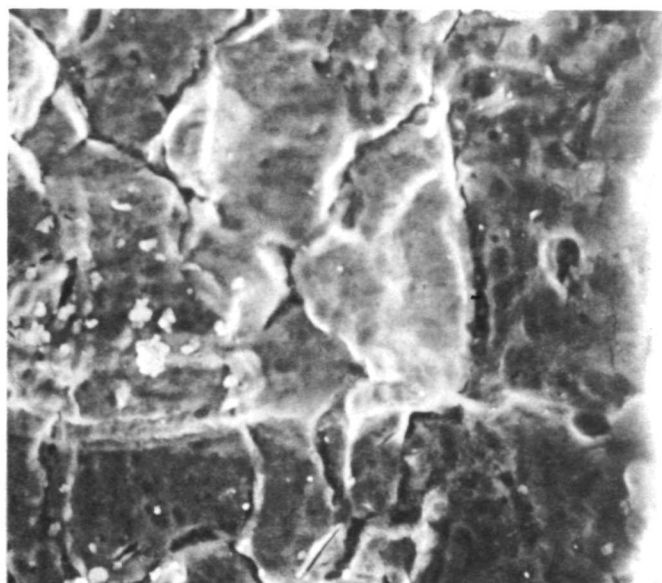
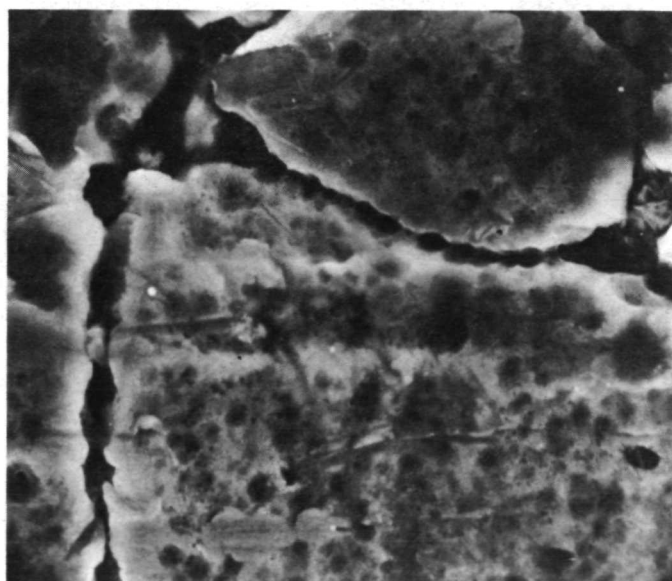
Figure 19

Appearance of Region A Outside the Crescent Region SS. These features are similar to those of region A in Figures 14 and 15.

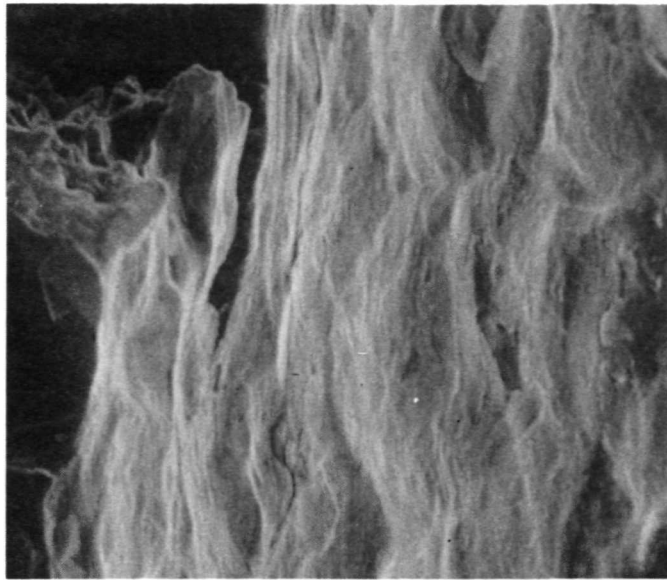
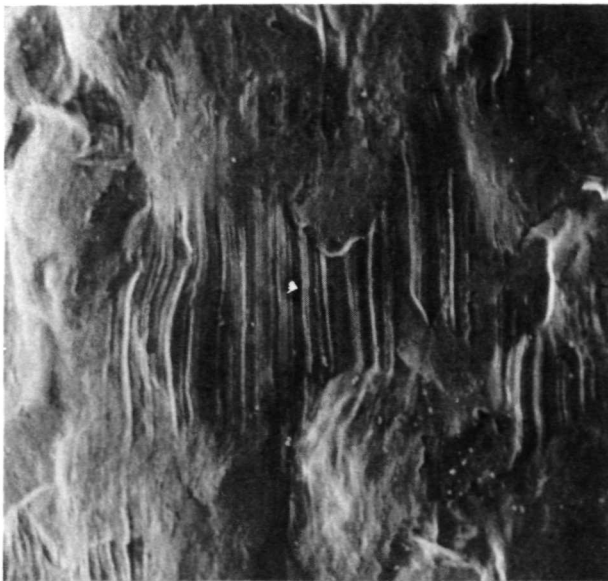
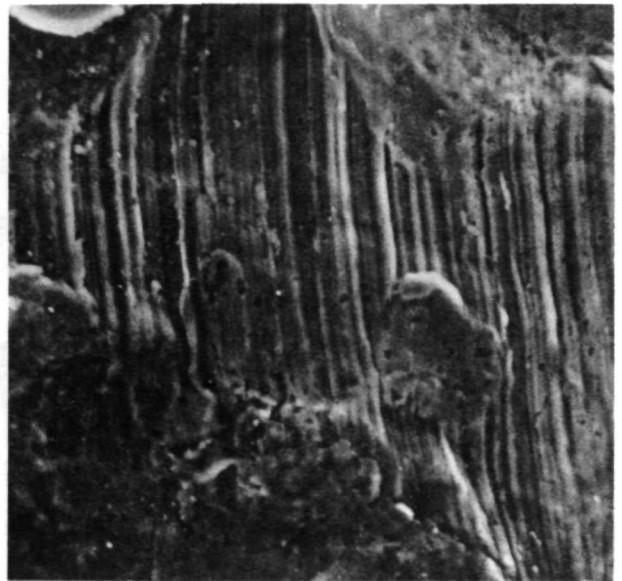
Figure 20

No specific cause of fracture origin could be established from the above observations. The crescent-shaped regions always occurred in a plane below the minimum cross-section plane containing most of the fracture. The specimen had been shot-peened, and a study of the shot-peened surface revealed many defects; some areas showed surface cracks and many areas showed original machine markings suggesting improper control of shot-peening parameters (Fig. 20).

Study of Shot-Peened Surface. (a) Crack on the shot-peened surface at the lower end of the crescent region SS. (b,c) Many areas on shot-peened surface showed presence of original machine markings. Some areas were either unexposed or lightly exposed to the shots, due to poor shot-peening control and hence resulted in local regions of high tensile stresses.

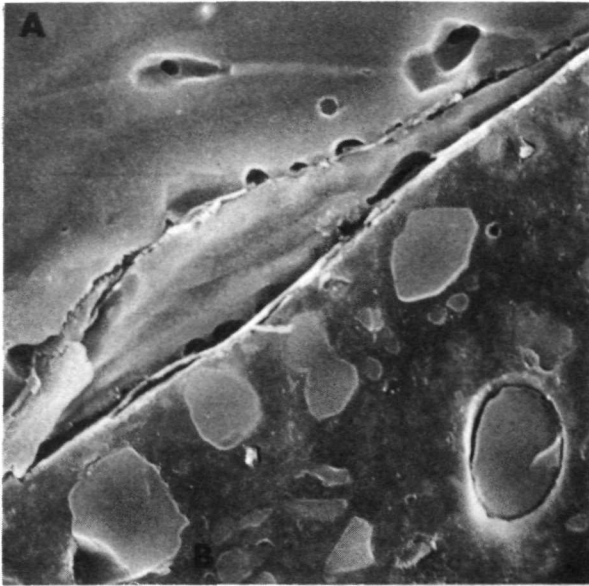
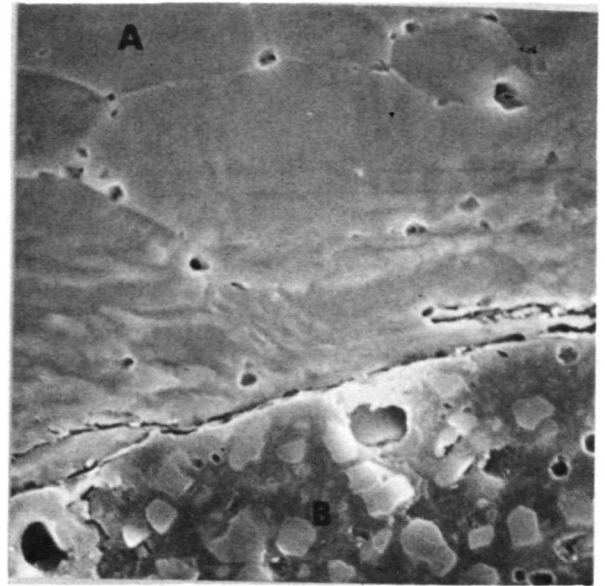
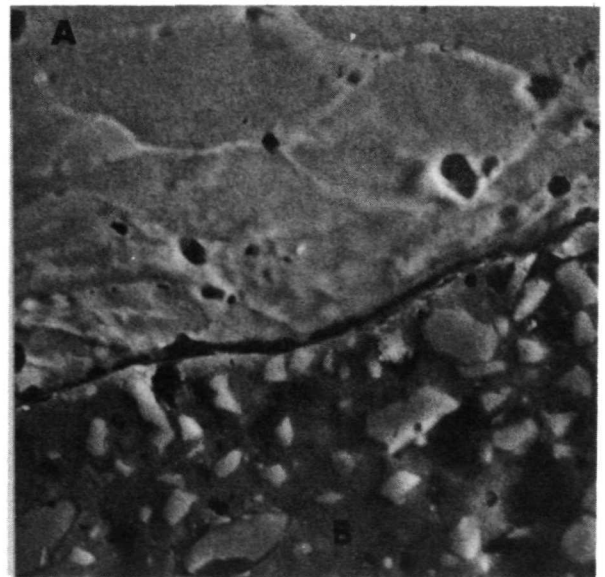
Figure 23

To further verify the shot peening damage a metallographic section was prepared (Figs. 21 and 22). Detailed SEM examination of this section (Fig. 23) revealed presence of many flaws and confirmed the uneven nature of shot-peening load distributions.

Four Views Showing Details of Shot-Peened Edge in Figure 22. Notice the extent of deformation induced and the nature of defects which are present. (All micrographs are secondary electron images in the SEM.) A is the alloy; B is bakelite.

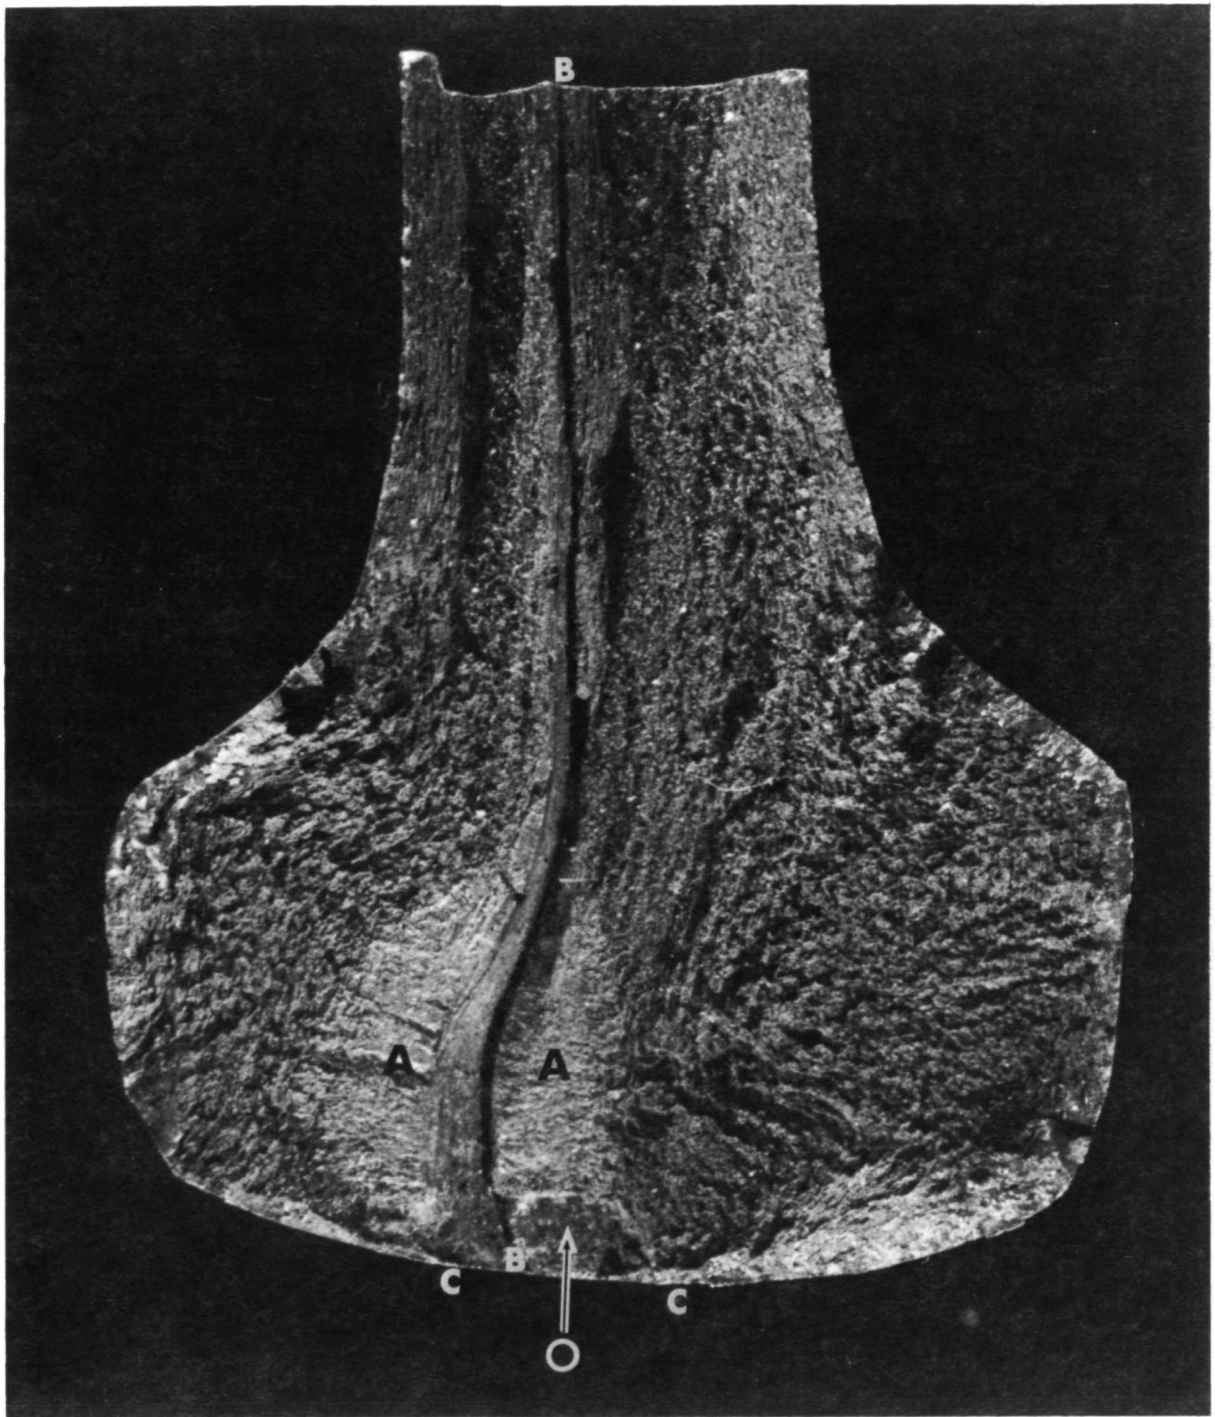
Figure 1

Fracture surface examined revealed three types of surfaces: The flaw surface, fatigue features originating near the flaw, and a region of overload fracture features. The fatigue surface was present on both sides of the flaw (areas marked A in Fig. 1). The remainder of the fracture surface was overload. The crack did not lead to final fracture because the section size increased after the crack propagated about 10 cm. Only about 2.5 cm of the crack surface (as shown in Fig. 1) was available to us for analysis.

Overview of the Fracture Surface of Failed Wing Spar Forging in the As-Received Condition (Optical Photomicrograph)

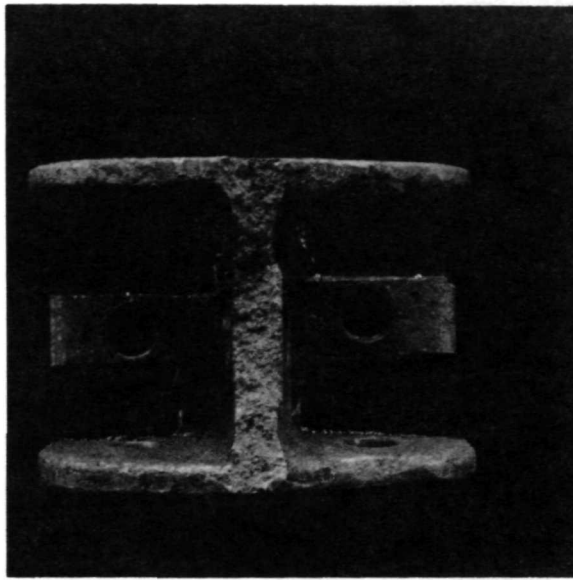
Figure 1

Optical Photomicrograph of Fracture  
in Bell Crank Fitting of Horizontal  
Elevator in As-Received Condition.

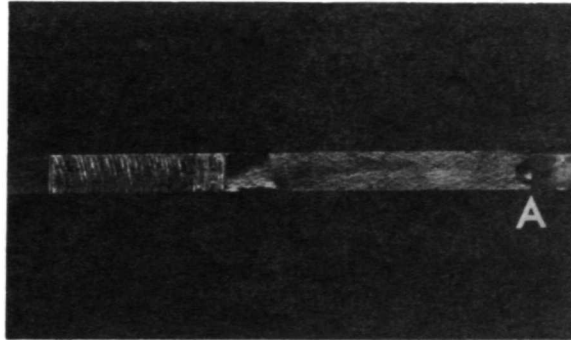
Figure 1

The Bomb Rack Plate in the Condition  
Received by IITRI. A is the edge near  
the hole where the fracture initiates.

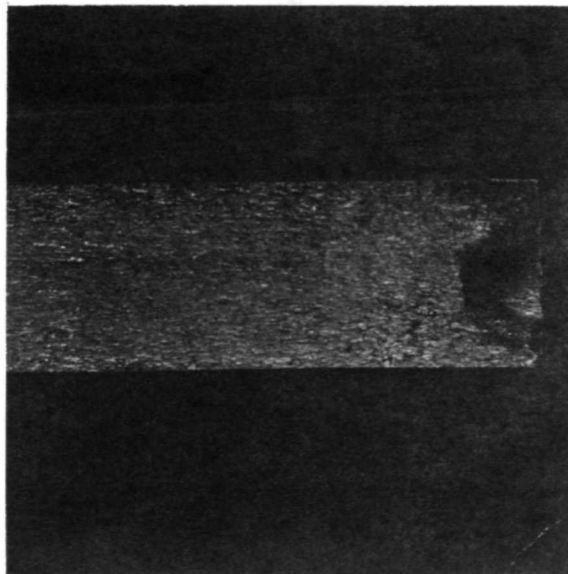
Figure 2

An Enlarged View of Area Near A.  
Notice the dark corrosion products  
on the right.

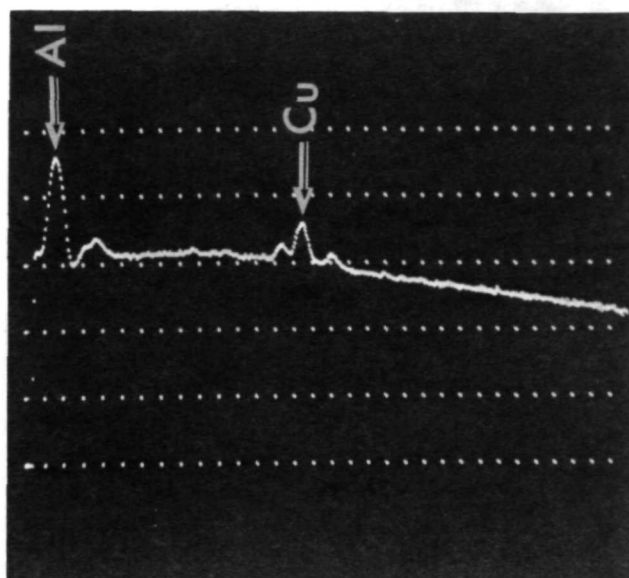
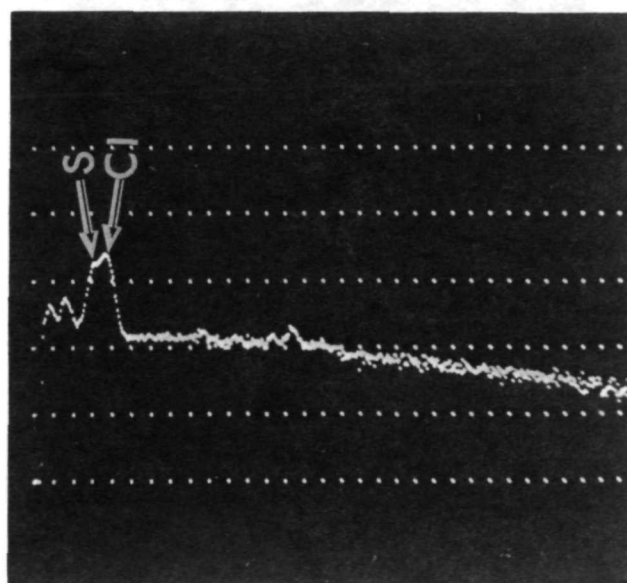
Figure 6

Analysis of Corrosion Debris (Figure 5c).  
 (a) X-ray spectrum; (b) standard spectrum  
 from  $\text{NaCl}$  and  $\text{Na}_2\text{SO}_4$  mixture indicating  
 the nature of peak when sulfur and chlorine  
 are present together.

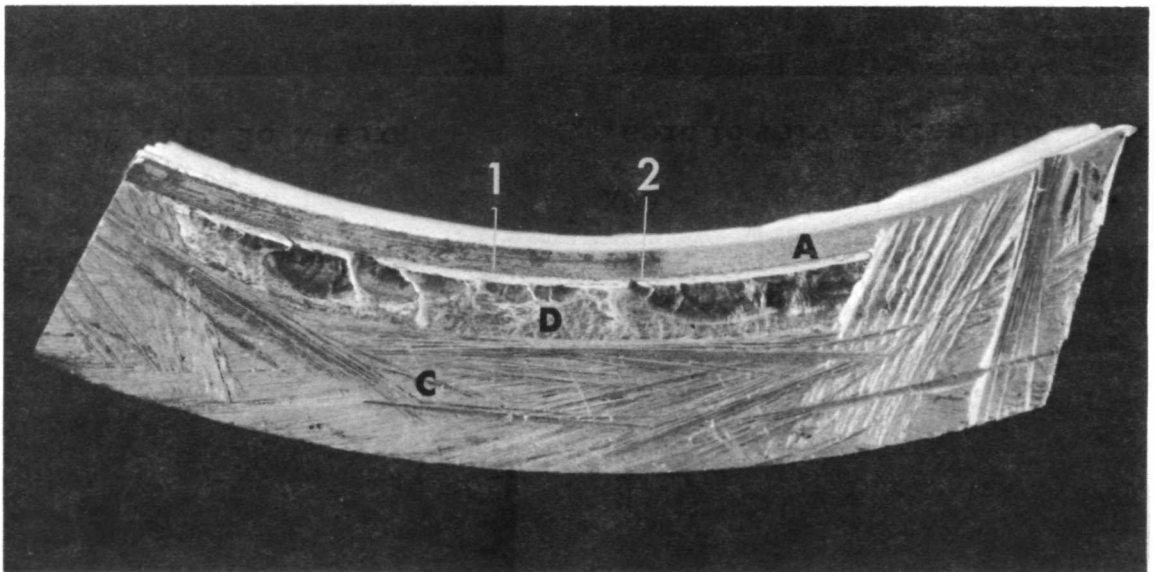
Opened up crack area, showing thread surface (A), crack surface (B), saw cutting marks (C), and overload region (D). Details of areas 1 and 2 are presented in Figs. 2 and 3.

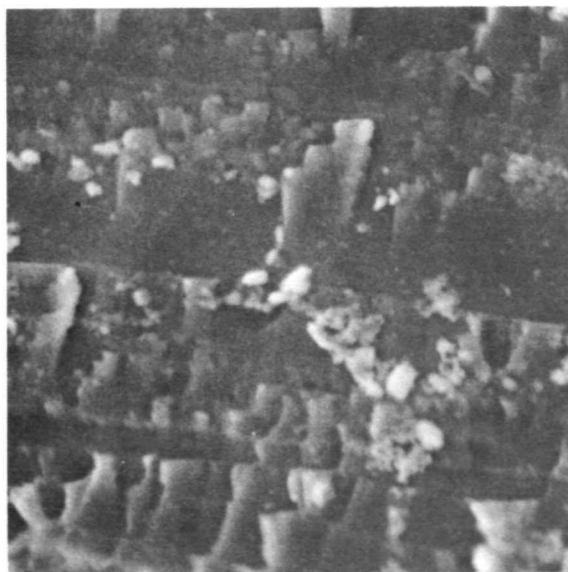
Area Z, showing fatigue features and corrosion products.
